PLUMTREE BRANCH WATERSHED STORMWATER RETROFIT STUDY

Howard County Department of Public Works
Bureau of Environmental Services
Stormwater Management Division
9801 Broken Land Parkway
Columbia, MD 21046

Biohabitats, Inc.
2081 Clipper Park Road
Baltimore, MD 21224

June 2019

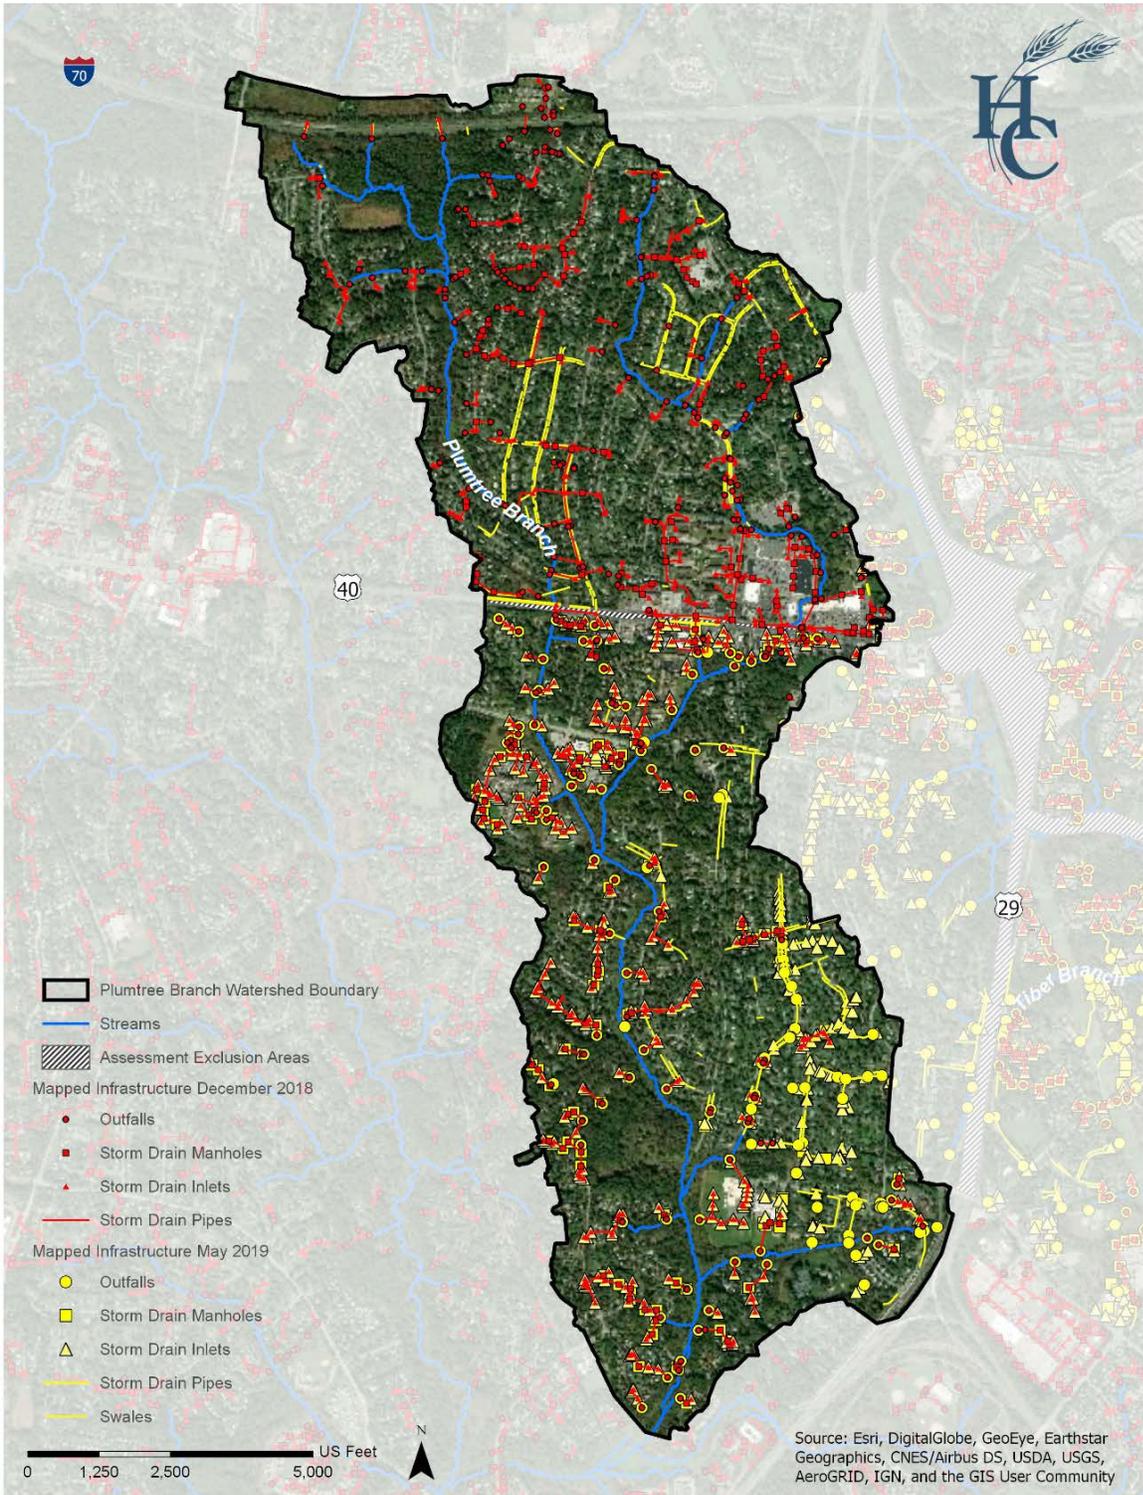
FIGURE 3.2. PLUMTREE BRANCH WATERSHED STORM DRAIN MAPPING, PRE AND POST FIELD ASSESSMENT

Field crews found that more than half of the watershed's constructed assets (pipes, manholes, inlets and outfalls) were mapped within the DPW asset database, except for in the area north of Baltimore National Pike where a similar study was conducted in 2017 for MDOT SHA. Figure 3.2 below shows the infrastructure located throughout the field assessment phase versus infrastructure that was mapped in the DPW assets database.

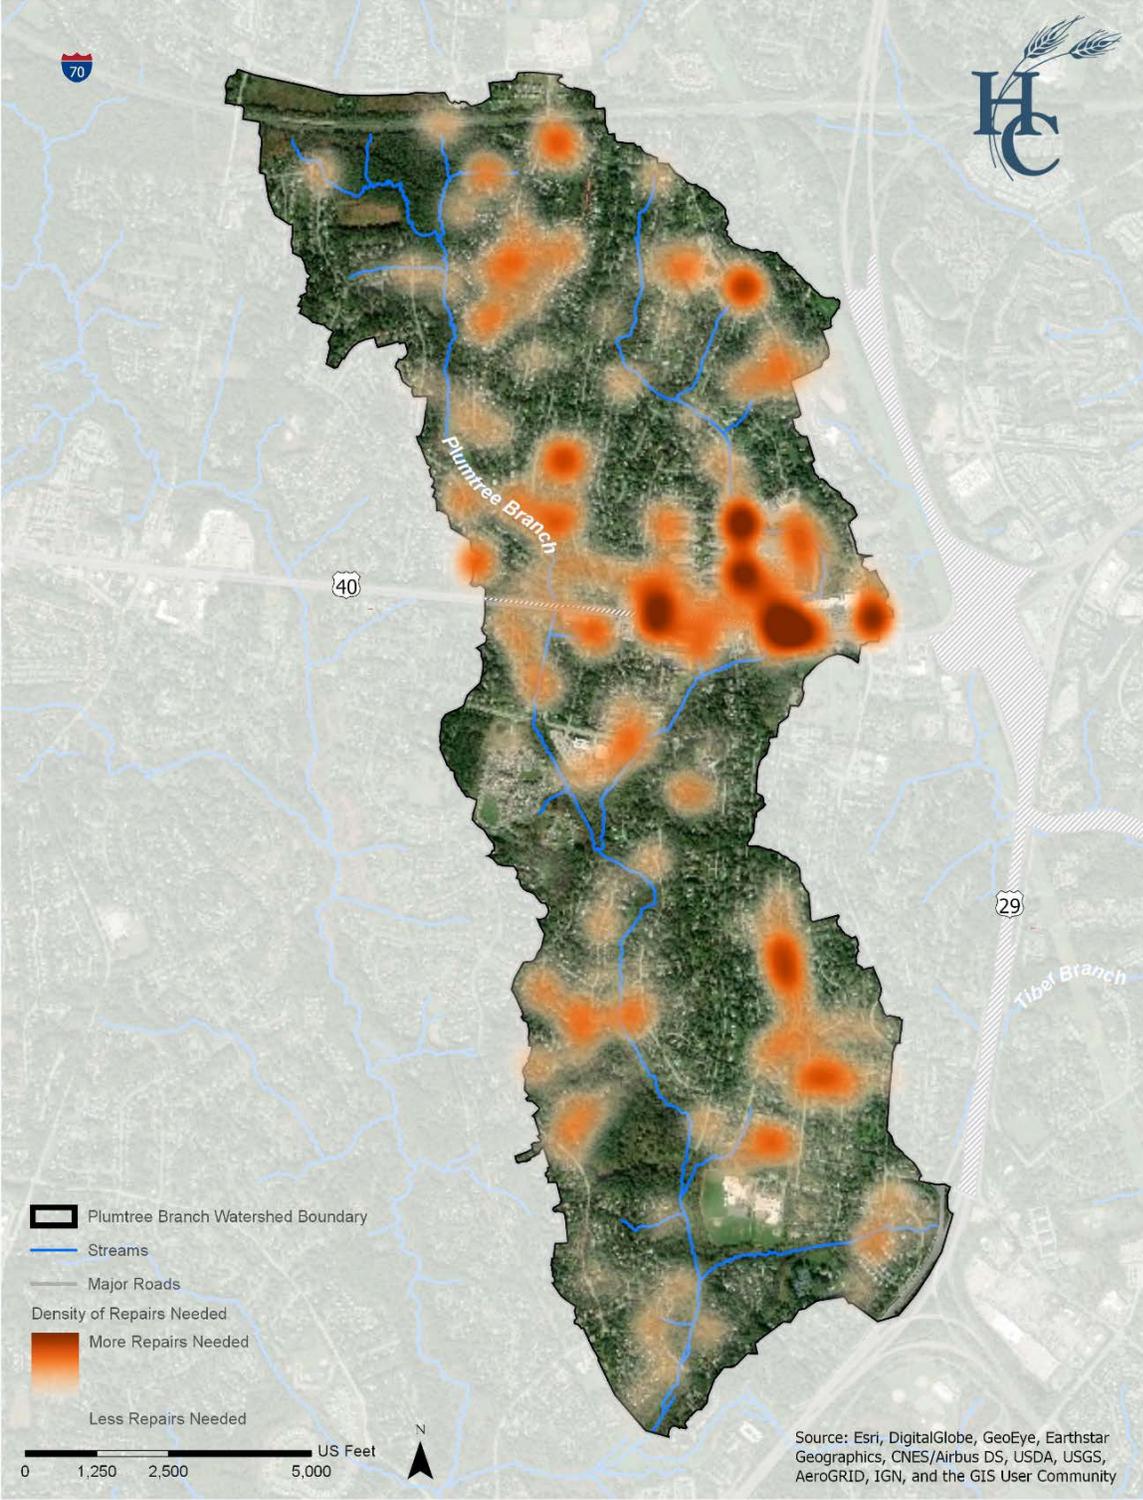
FIGURE 3.3. PLUMTREE BRANCH WATERSHED STORM DRAIN CONDITION

Field crews found that infrastructure designated as "Further Investigation Recommended" was often clustered geographically. A heat map, shown in Figure 3.3 below, demonstrates some observed geographic patterns. The infrastructure conditions found during the field assessment are summarized in Figure 3.4 below.

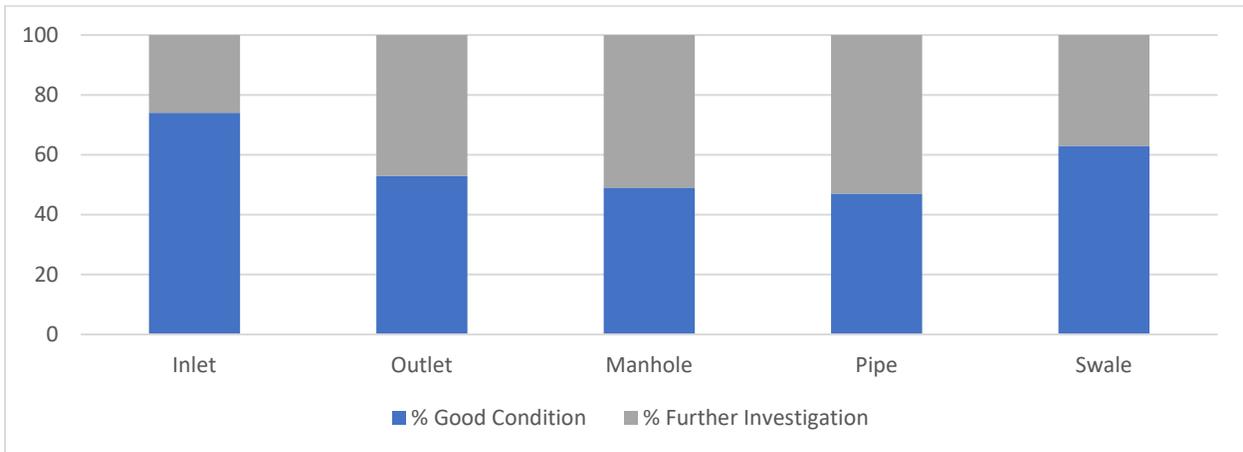
FIGURE 3.4. ASSET CONDITION BY TYPE

Field crews rated assets as good condition or in need of further investigation, a rating that includes assets in need of inspection, cleaning, repair, or replacement. The asset type most likely to fall into the "further investigation recommended" category is pipes. Inlets are the asset type least likely to require further investigation.

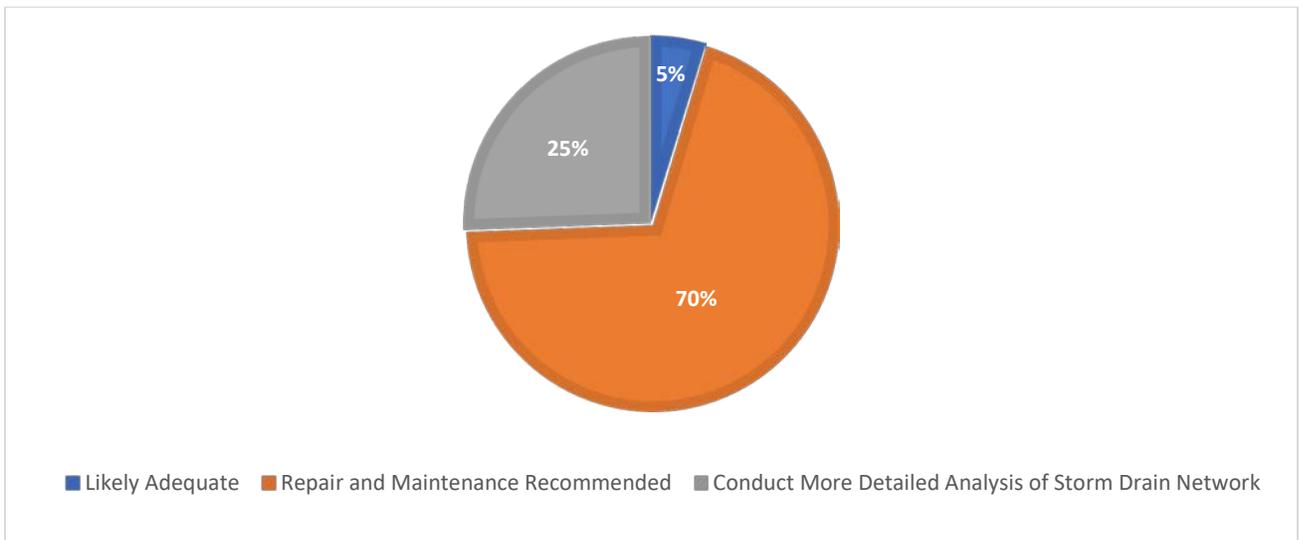
FIGURE 4.1. RESULTS OF STORM DRAIN ANALYSIS

As depicted in Figure 4.1. below, the majority of storm drain systems fell into either Repair and Maintenance Recommended or Conduct More Detailed Analysis of Storm Drain Network. Full results are included in Appendix F.
