# TIBER BRANCH WATERSHED STORMWATER RETROFIT STUDY

Howard County Department of Public Works  
Bureau of Environmental Services  
Stormwater Management Division  
9801 Broken Land Parkway  
Columbia, MD 21046

Biohabitats, Inc.  
2081 Clipper Park Road  
Baltimore, MD 21224

June 2019

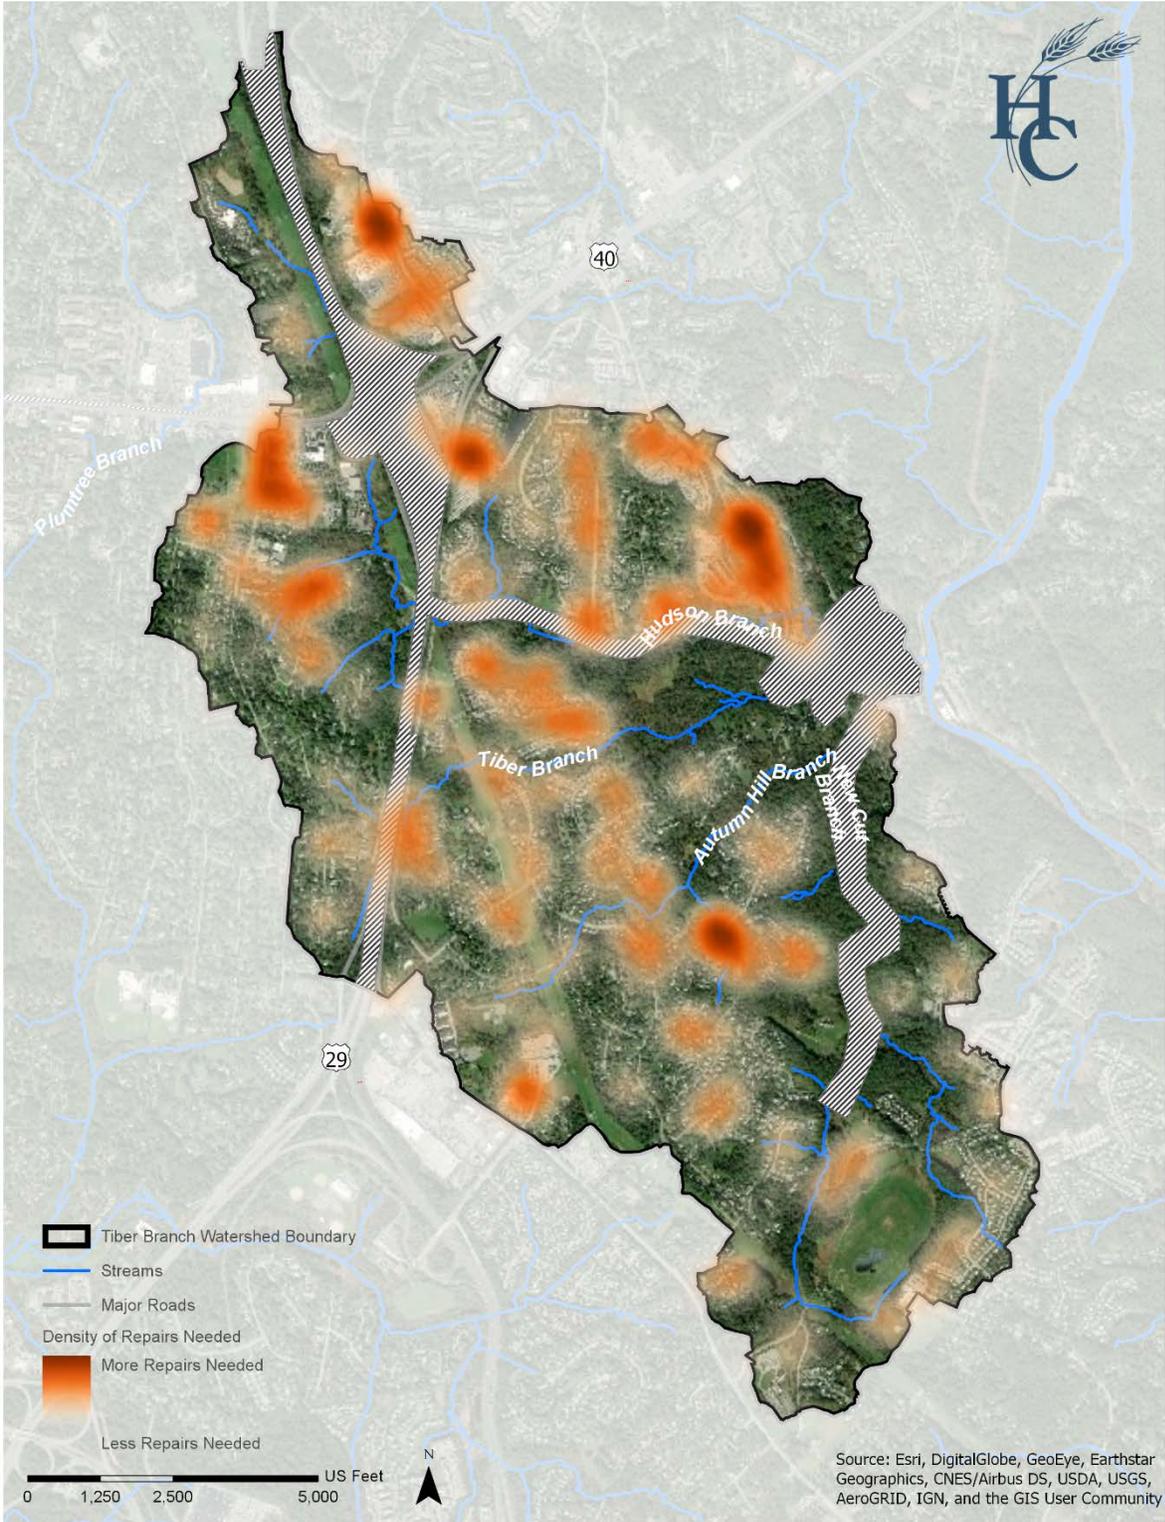
FIGURE 3.3. TIBER BRANCH WATERSHED STORM DRAIN CONDITION

Field crews found that infrastructure designated as "Further Investigation Recommended", does not follow any pattern. A heat map, shown in Figure 3.3 below, demonstrates this overall lack of pattern. The infrastructure conditions found during the field assessment are summarized in Figure 3.4 below.

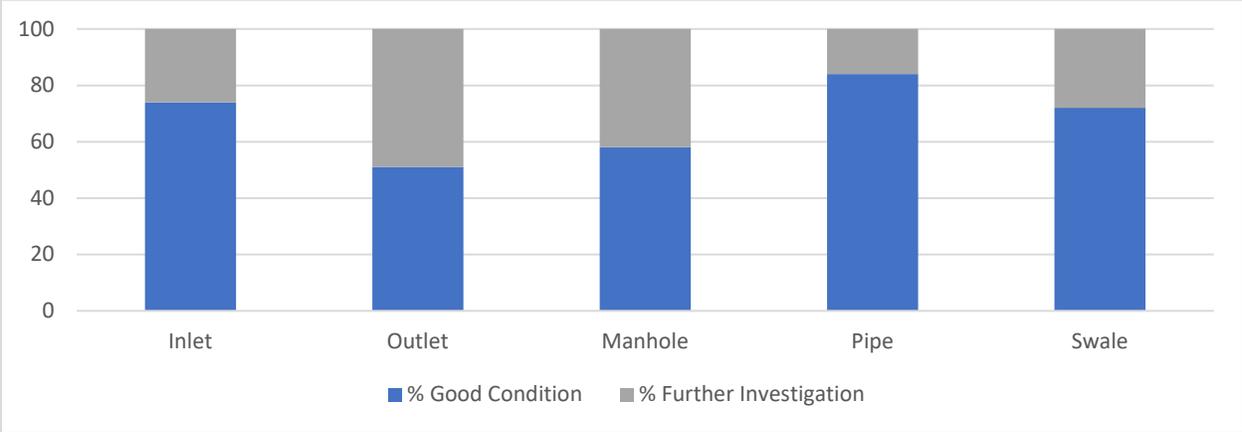
FIGURE 3.4. ASSET CONDITION BY TYPE

Field crews rated assets as good condition or in need of further investigation, a rating that includes assets in need of inspection, cleaning, repair, or replacement. The asset type which most often fell into the "further investigation recommended" category is outfalls. About half of the outfalls in the watershed received this rating. Pipes are the asset type least likely to require further investigation.

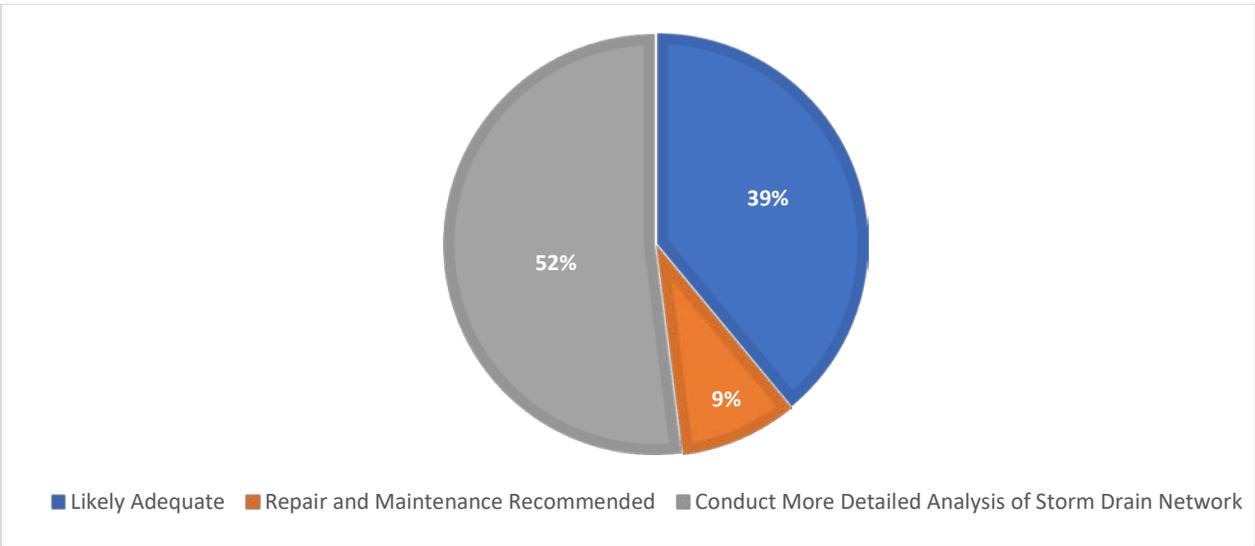
FIGURE 4.1. RESULTS OF STORM DRAIN ANALYSIS

As depicted in Figure 4.1. below, the majority of storm drain systems fell into either Repair and Maintenance Recommended or Conduct More Detailed Analysis of Storm Drain Network. Full results are included in Appendix F.
