PLUMTREE BRANCH WATERSHED STORMWATER RETROFIT STUDY

Howard County Department of Public Works
Bureau of Environmental Services
Stormwater Management Division
9801 Broken Land Parkway
Columbia, MD 21046

Biohabitats, Inc.
2081 Clipper Park Road
Baltimore, MD 21224

June 2019

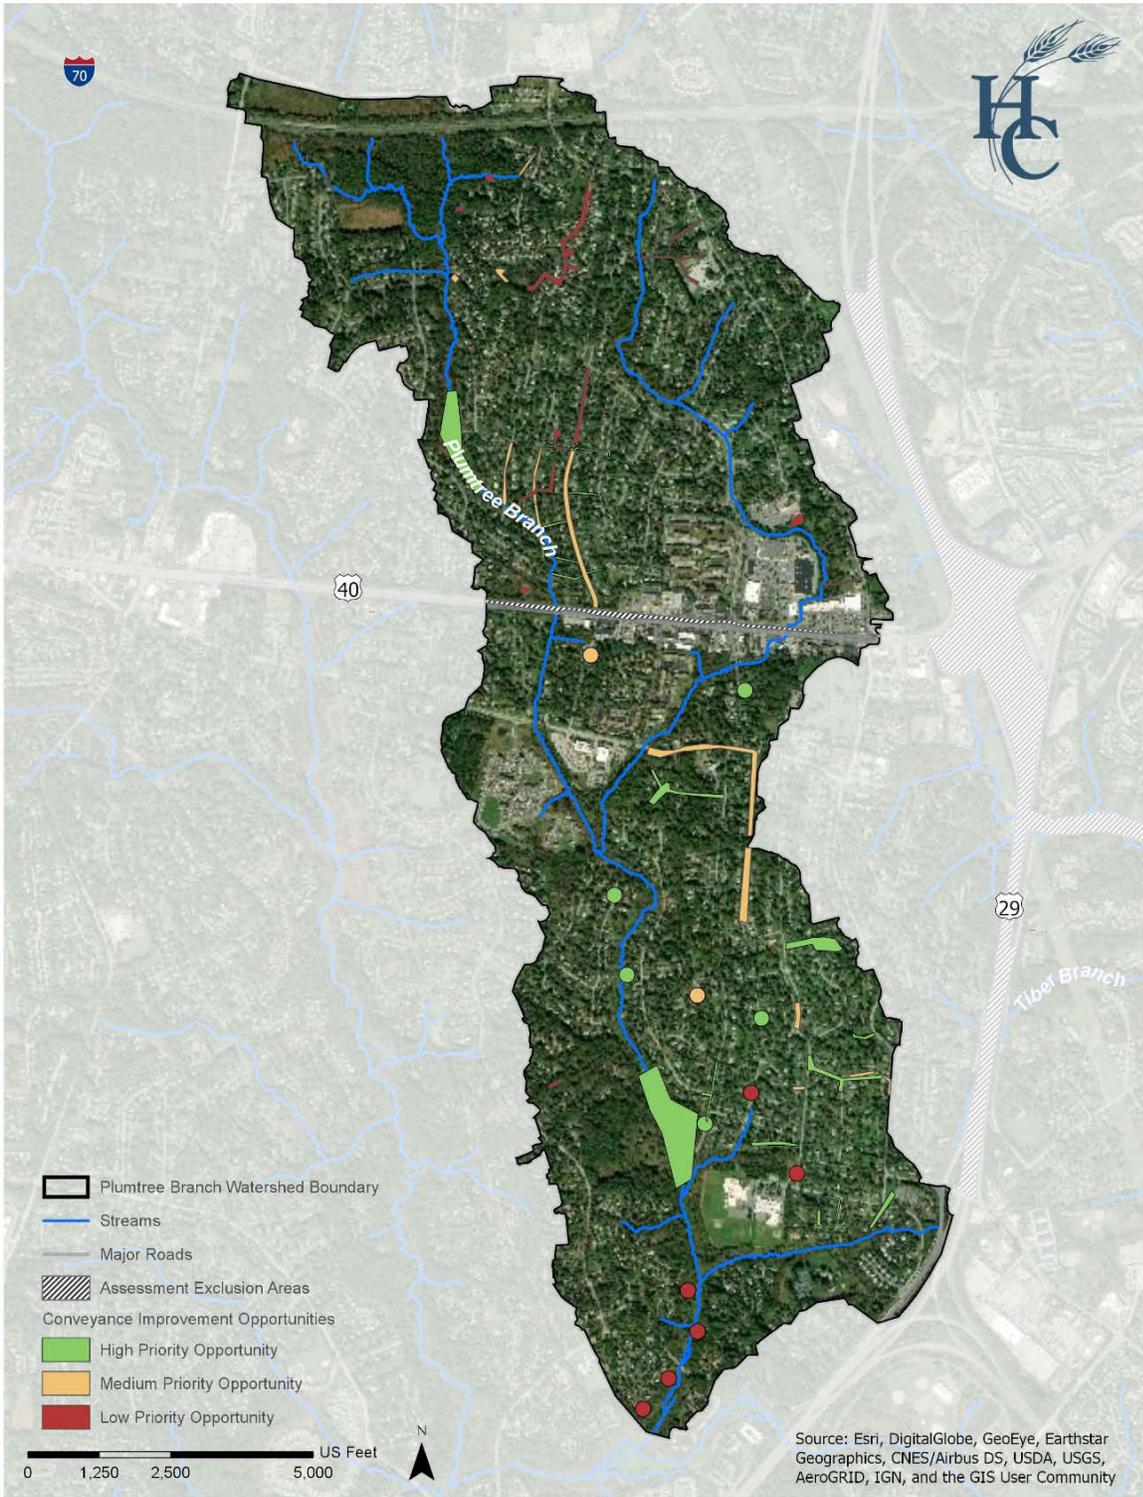
FIGURE 3.5. PLUMTREE BRANCH WATERSHED RETROFIT AND DRAINAGE IMPROVEMENT OPPORTUNITIES

A preliminary prioritization process (discussed in detail in Section 3.3.3) was conducted to help differentiate projects based on select criteria such as ability to address a clear obstacle to runoff conveyance and few obstacles to implementation. This process is intended to inform future planning by DPW when identifying projects that will move forward to implementation through the County's CIP program.

A map of all collected opportunities can be found in Figure 3.5.

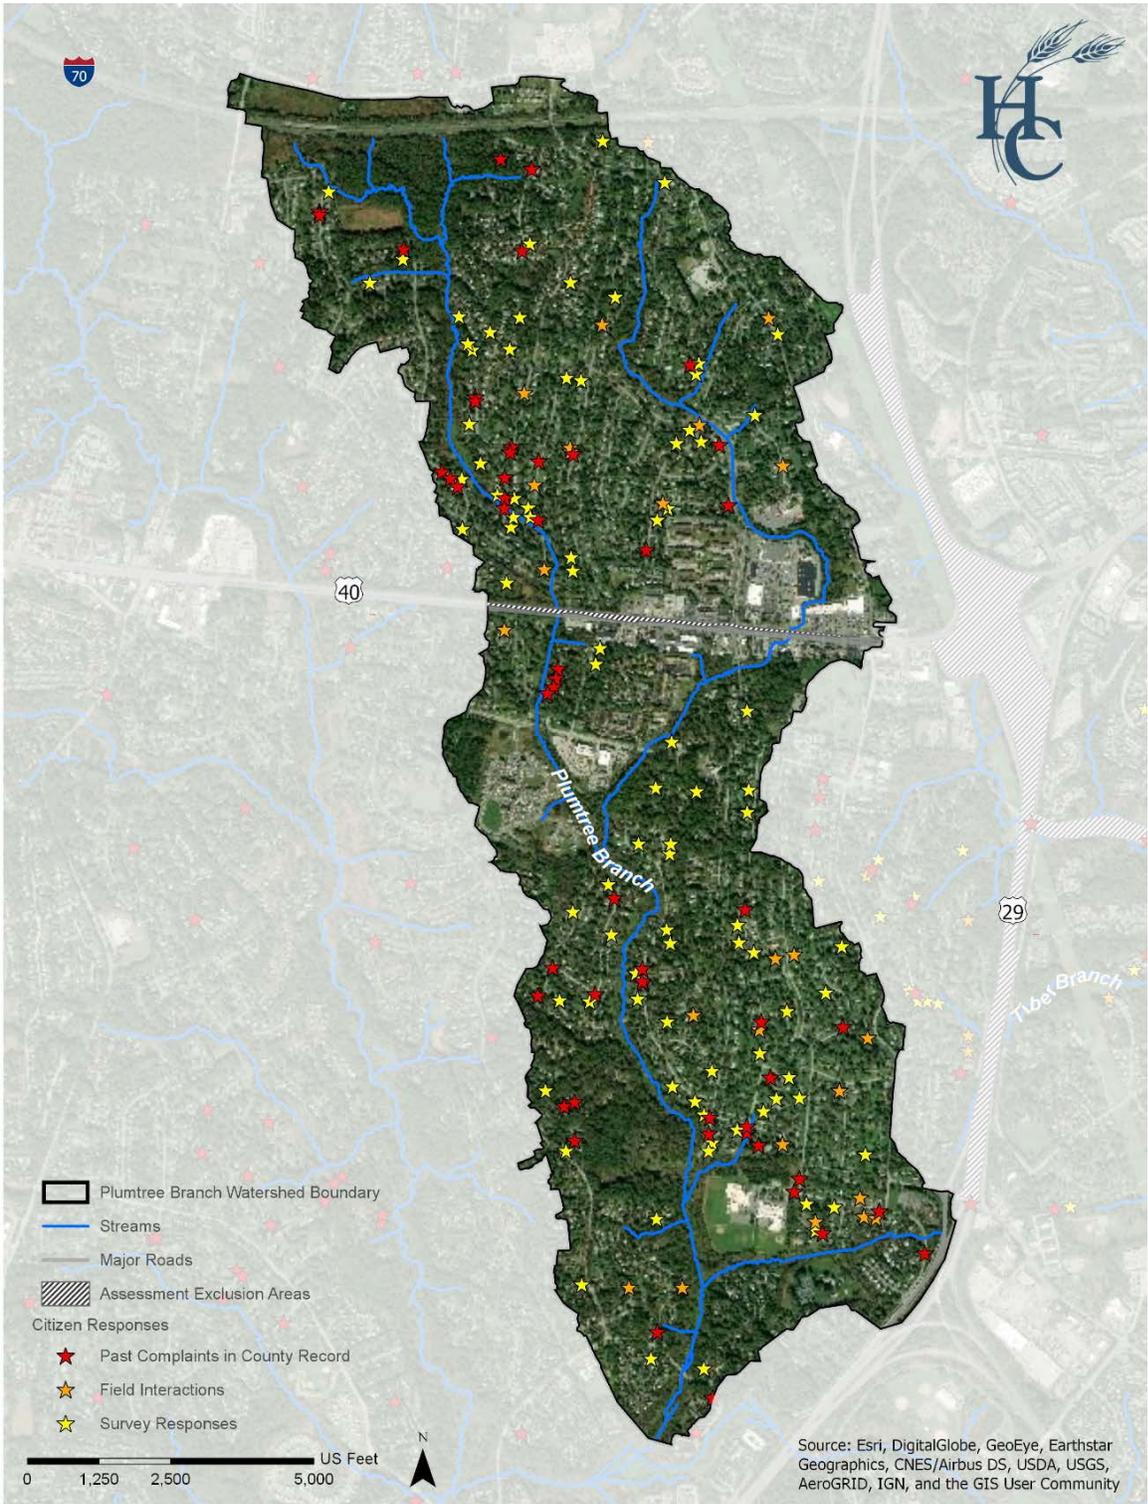
FIGURE 3.7. PLUMTREE BRANCH WATERSHED COMMUNITY INPUT

During the field work, field crews were often approached by residents who shared information on the history of the storm drainage issues in their neighborhood and commentary on specific issues they had observed. Several residents described issues during past storm events that had not been reported to the County via the survey or the complaints database. Field crews were more frequently approached in milder weather, so the frequency and location of field-interactions is somewhat weather dependent and does not necessarily correlate to the severity of drainage issues in a given area. The locations of field interactions with input relevant to the study are mapped in Figure 3.7.

During the field assessment phase, residents contacted DPW with comments via telephone or email. The locations of these additional community inputs are also mapped on Figure 3.7.

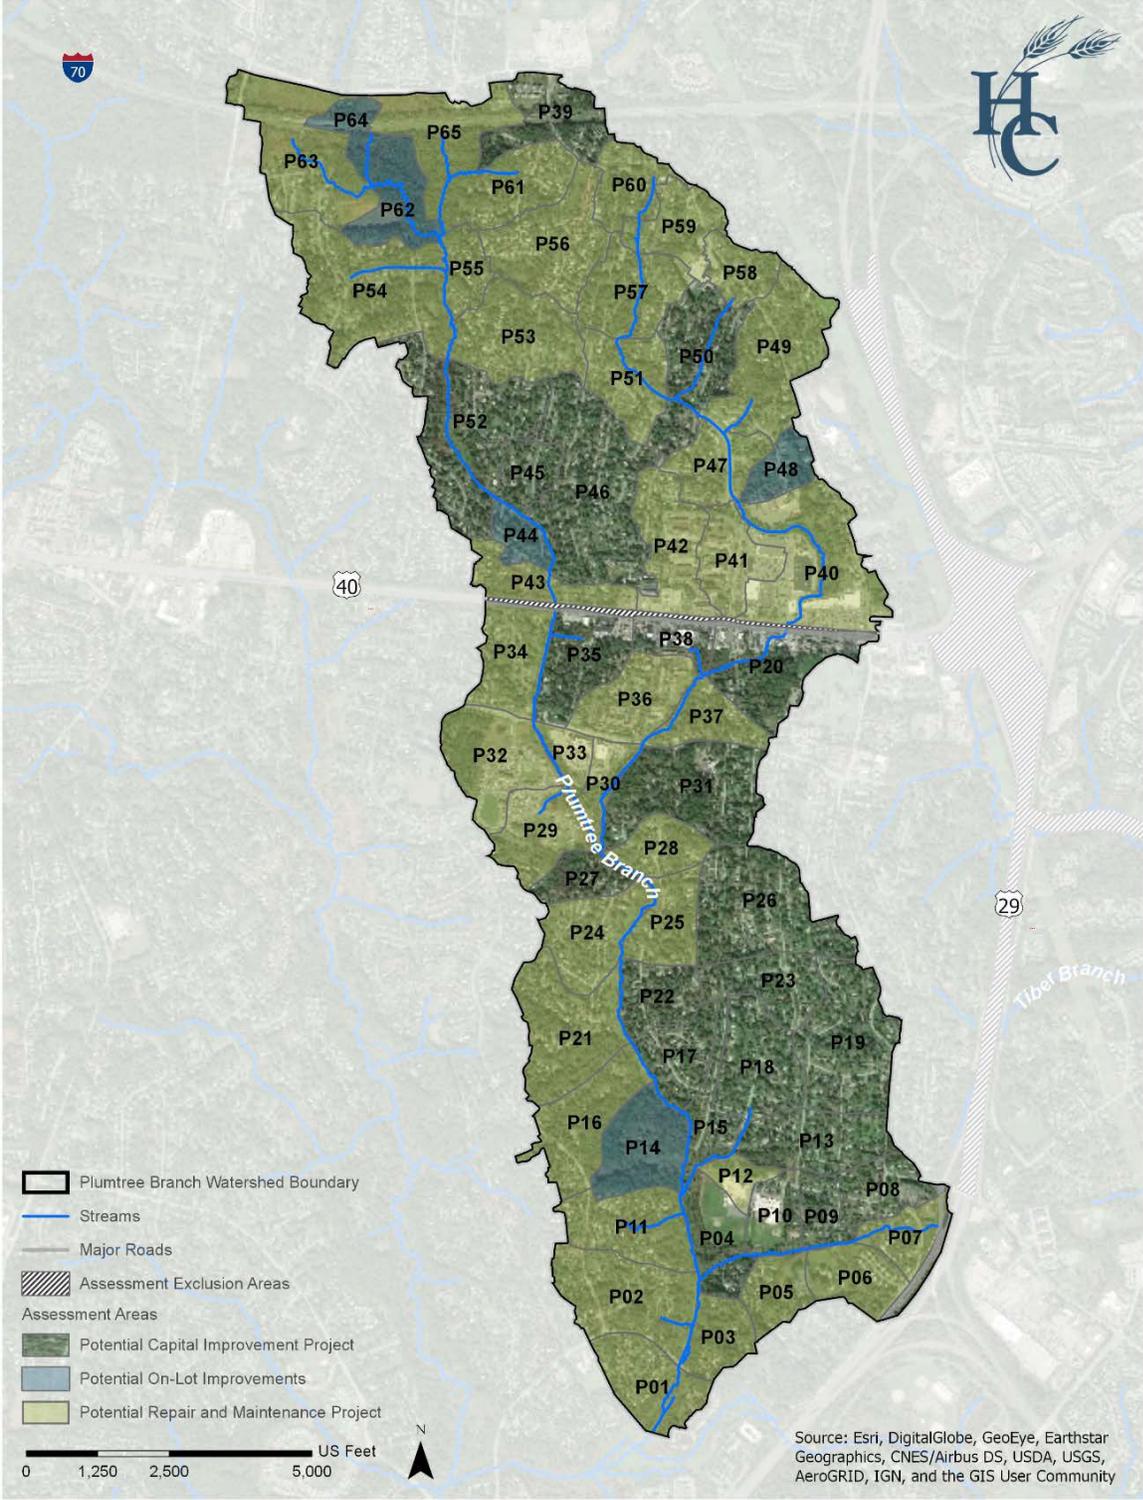
FIGURE 4.2. PLUMTREE BRANCH WATERSHED CATCHMENTS AND ASSESSMENT AREAS

Assessment Areas were placed into one of three categories based on the results of any applicable storm drain analyses, the ratings of any identified opportunities, and community input data located within each Assessment Area. The three Assessment Area categories are (see Figure 4.2):

The final category of Assessment Areas is those where any drainage concerns are limited to property-to-property stormwater runoff. Specific opportunities were not identified by field crews, since any work performed would be the responsibility of individual residents. Only five areas were placed in the Potential On-Lot Improvements category.
