# TIBER BRANCH WATERSHED STORMWATER RETROFIT STUDY

Howard County Department of Public Works  
Bureau of Environmental Services  
Stormwater Management Division  
9801 Broken Land Parkway  
Columbia, MD 21046

Biohabitats, Inc.  
2081 Clipper Park Road  
Baltimore, MD 21224

June 2019

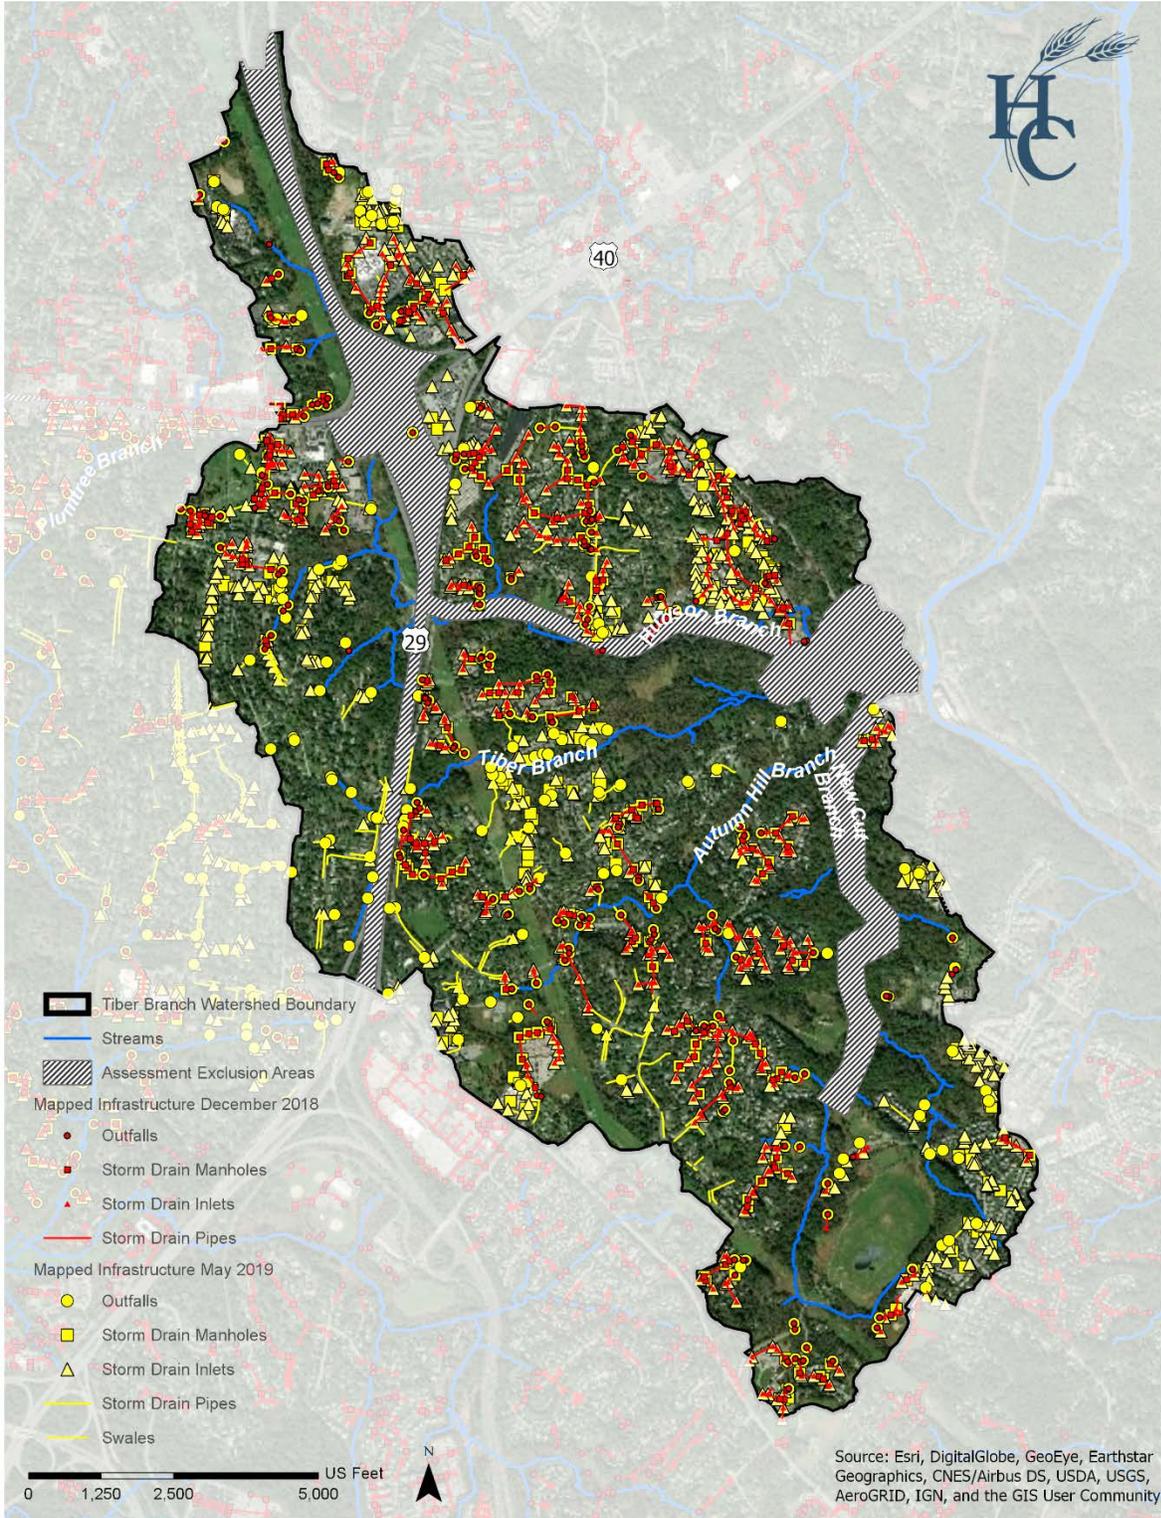
FIGURE 3.2. TIBER BRANCH WATERSHED STORM DRAIN MAPPING, PRE AND POST FIELD ASSESSMENT

Field crews found that about half of the watershed's constructed assets (pipes, manholes, inlets and outfalls) were mapped within the DPW asset database. Generally, if some assets from a development were mapped, then all assets were mapped, but otherwise there was no clear pattern as to what assets had been mapped in the DPW asset database. Figure 3.2 below shows the infrastructure located throughout the field assessment phase versus infrastructure that was mapped in the DPW asset database.

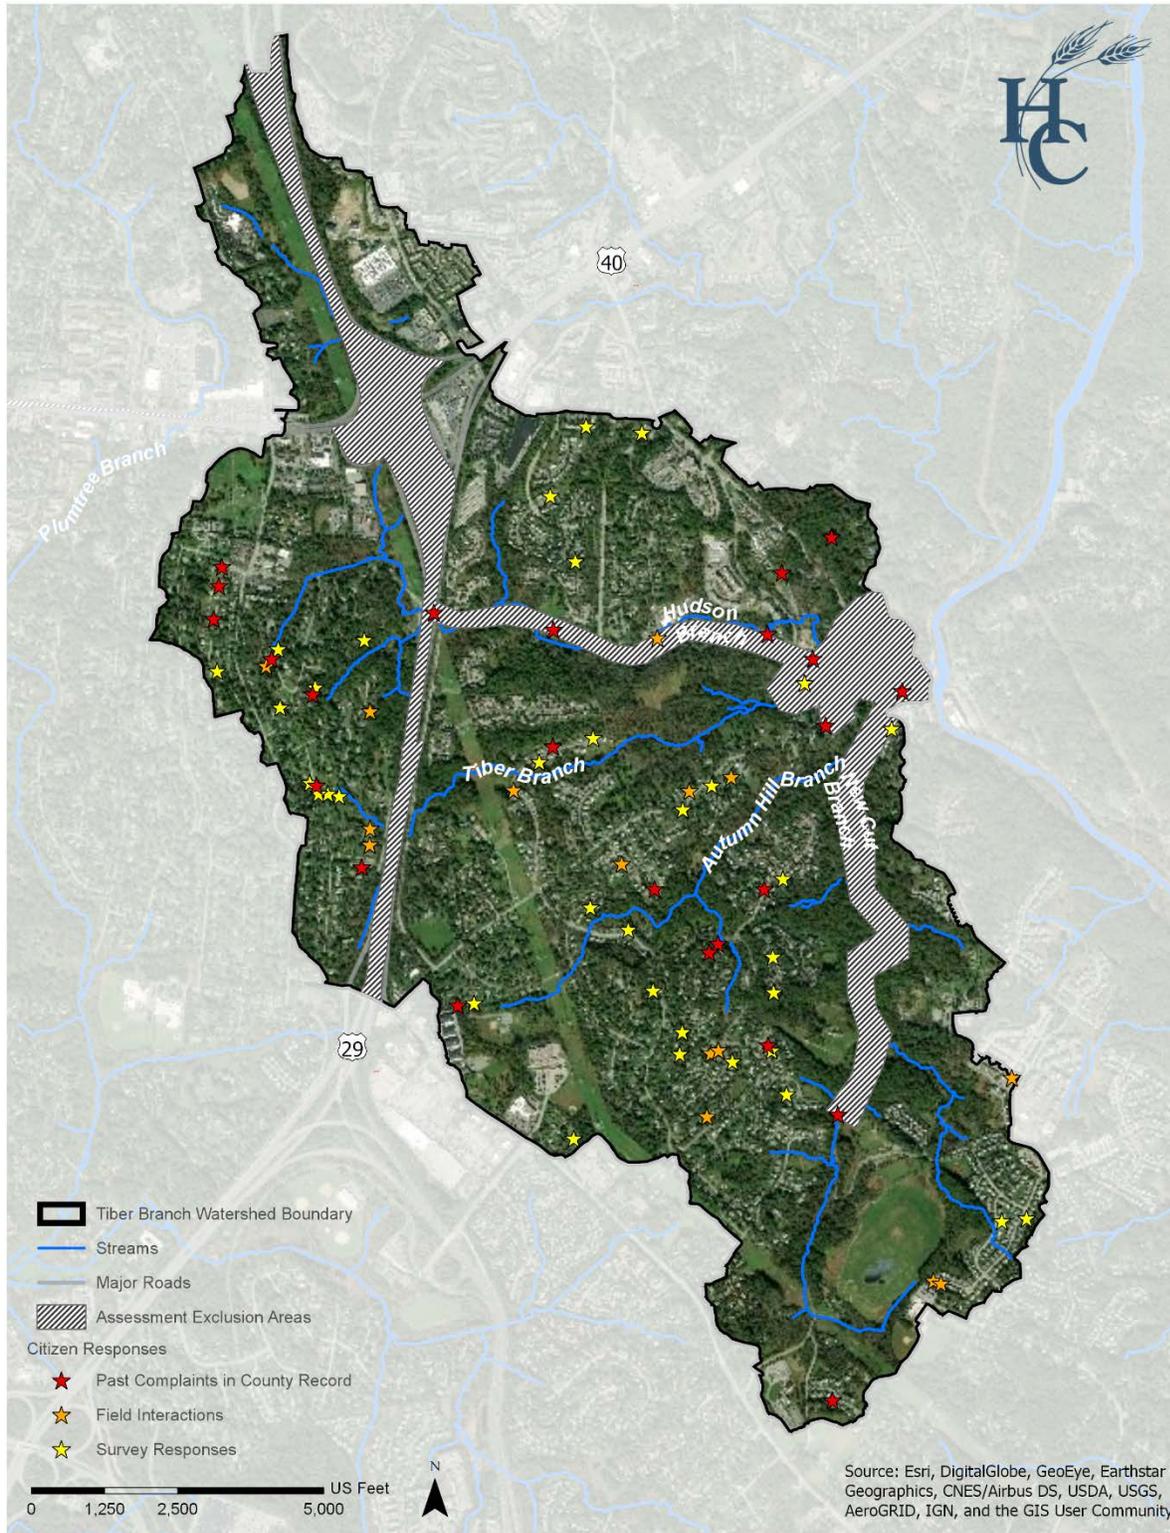
FIGURE 3.7. TIBER BRANCH WATERSHED COMMUNITY INPUT

The locations of the addresses provided by the complainant are depicted in Figure 3.7. The complainant's address is not necessarily the location of the stormwater issue but are generally located in the same vicinity.

During the field work, field crews were often approached by residents who shared information on the history of the storm drainage issues in their neighborhood and commentary on specific issues they had observed. Several residents described issues during past storm events that had not been reported to the County via the survey or the complaints database. Field crews were more frequently approached in milder weather, so the frequency and location of field-interactions is somewhat weather dependent and does not necessarily correlate to the severity of drainage issues in a given area. The locations of field interactions with input relevant to the study are mapped in Figure 3.7.

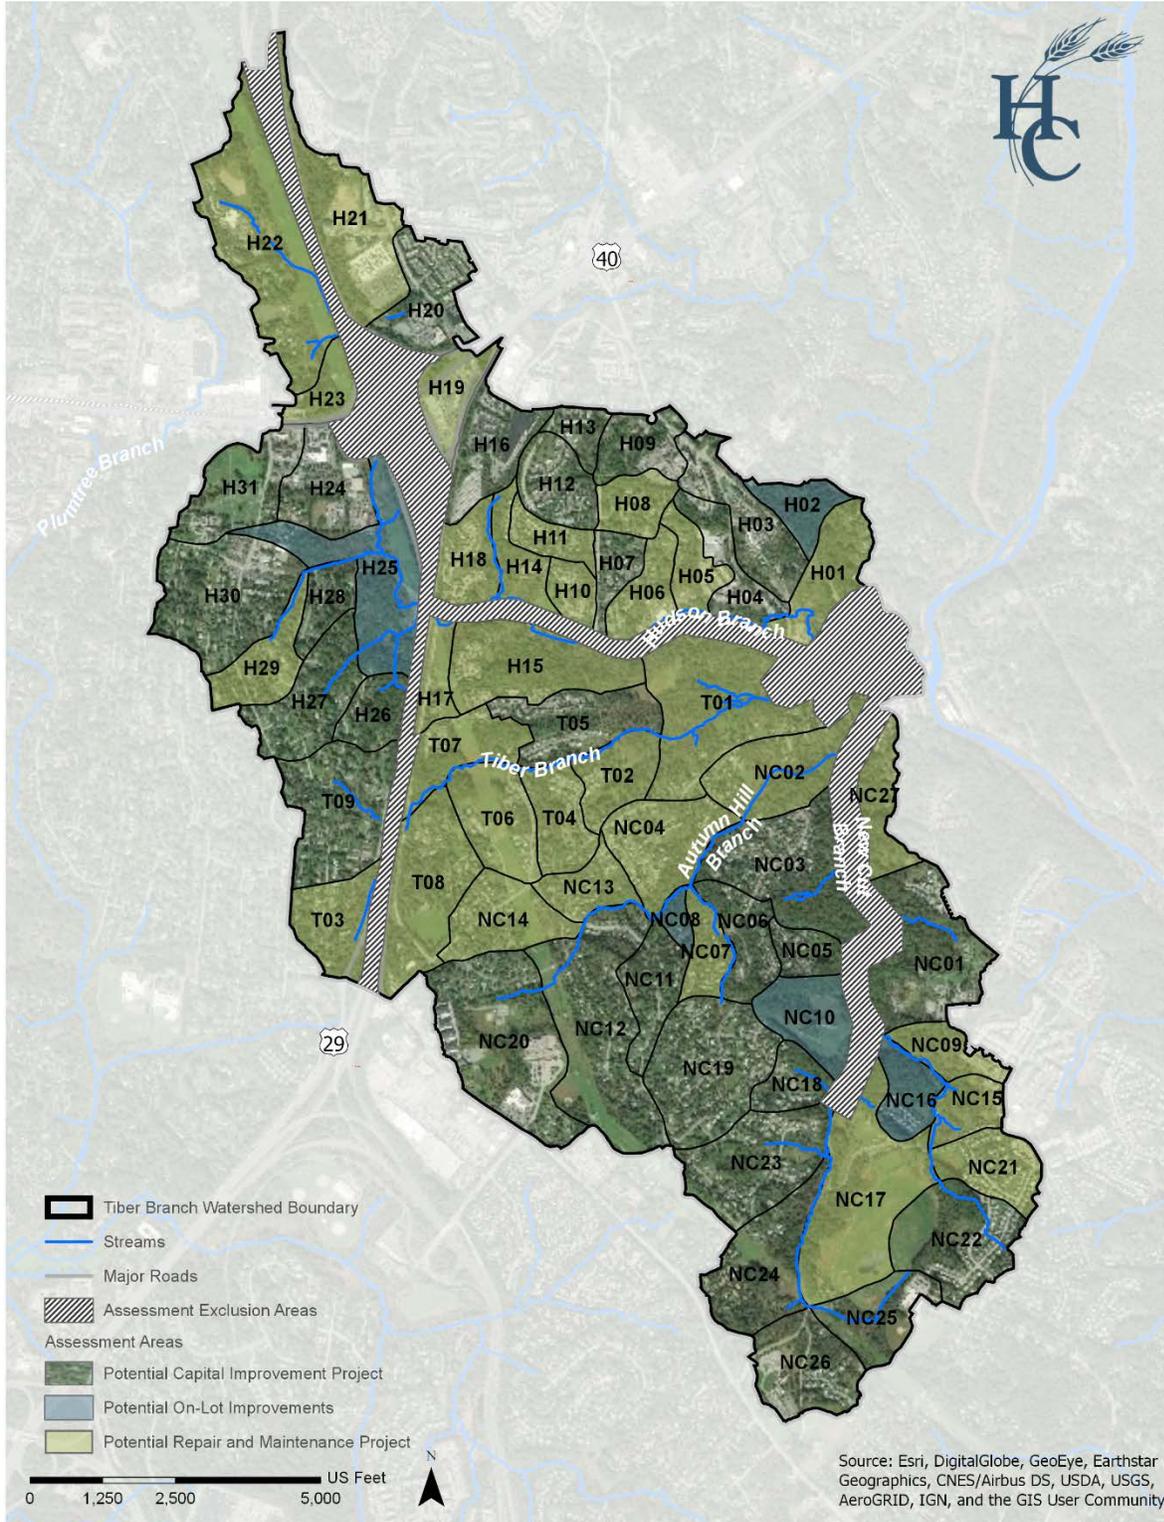
FIGURE 4.2. TIBER BRANCH WATERSHED CATCHMENTS AND ASSESSMENT AREAS

Assessment Areas were placed into one of three categories based on the results of any applicable storm drain analyses, the ratings of any identified opportunities, and community input data located within each Assessment Area. The three Assessment Area categories are (see Figure 4.2):
